**Flood Control Project Maintenance
Levee Inspections**

Maintenance Issue Types Only, Levee Inspection Report By Mile - Spring 2019

Reclamation District No. 0349 Sutter Island

Waterway	Bank	Unit Miles	Inspection Start/End	Inspector
Unit No. 01 Sacramento River	Right	1.59	03/19/2019 03/19/2019	David Julian

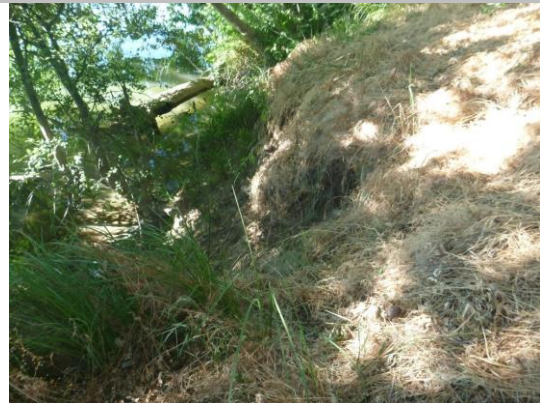
LM Start	2.11	Rating **	A/W	Issue No.	25
LM End	2.14	Issue Type +	Ma	Location *	WS
Category	Supplemental			GPS Latitude/Longitude	
				Start	End
Item	2017 USACE Erosion Survey, DRAFT			38.279017 °	38.278597 °
				-121.589615 °	-121.589854 °
DWR ID	DWR_RD0349_02_f_2018_25				
Comment Code					
Inspector Comment					
2017 Site ID: STM 23.9 R Status: Eroding 2017 Field Notes: No observed change. Site History: 1997 - Top right bank has retreated into the levee. Site is between two rock sites. 1999 - Downstream half of the reach repaired with rock. 2000 - Trees leaning into the water. 2010 - Site appears worse. 2011 - New erosion at the toe. 2013 - Short vertical sections observed at upstream end. 2015 - Minor new erosion.

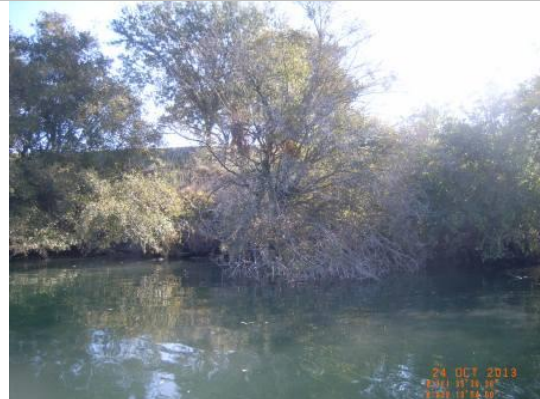
Photo 1 of 1 : SP_2019_RD0349_206_115_20190311_00020.jpg

Comment Code					
Inspector Comment					
2017 Site ID: STR 26.5 L Status: Eroding 2017 Field Notes: There appears soil under geotech fabric that appears to be failing but hard to tell. Site History: 2002 - Original rock over geotextile is sliding off and the end is coming unraveled. 2003 - Some minor new erosion on the downstream end. 2004 - Site has gotten worse. Underlined geofabric is exposed. 2005 - Still looks bad with exposed geotextile fabric. 2006 - Still have some new unraveling and exposed fabric. Site lengthened upstream. 2009 - Minimal new erosion. 2010 - geotextile fabric placed since last year, possible flood fight. 2012 - Exposed geotech style fabric, assume rock on top slid off. 2015 - Erosion pockets covered with plastic. 2018 DWR Inspector: This was rated as A/W due to the inability to verify the rating at the time of inspection. This site will be verified during the next inspection.
